# Meeting the Challenges of Characterizing Subsurface Conditions in Bouldery Terrain

SHALLER, Philip J.<sup>1</sup>, MEDLEY, Edmund<sup>2</sup>, and SUTARWALA, Seema<sup>3</sup>

Exponent Failure Analysis Associates Civil Group  
<sup>1</sup> Irvine, CA, <sup>2</sup> Menlo Park, CA, <sup>3</sup> Los Angeles, CA

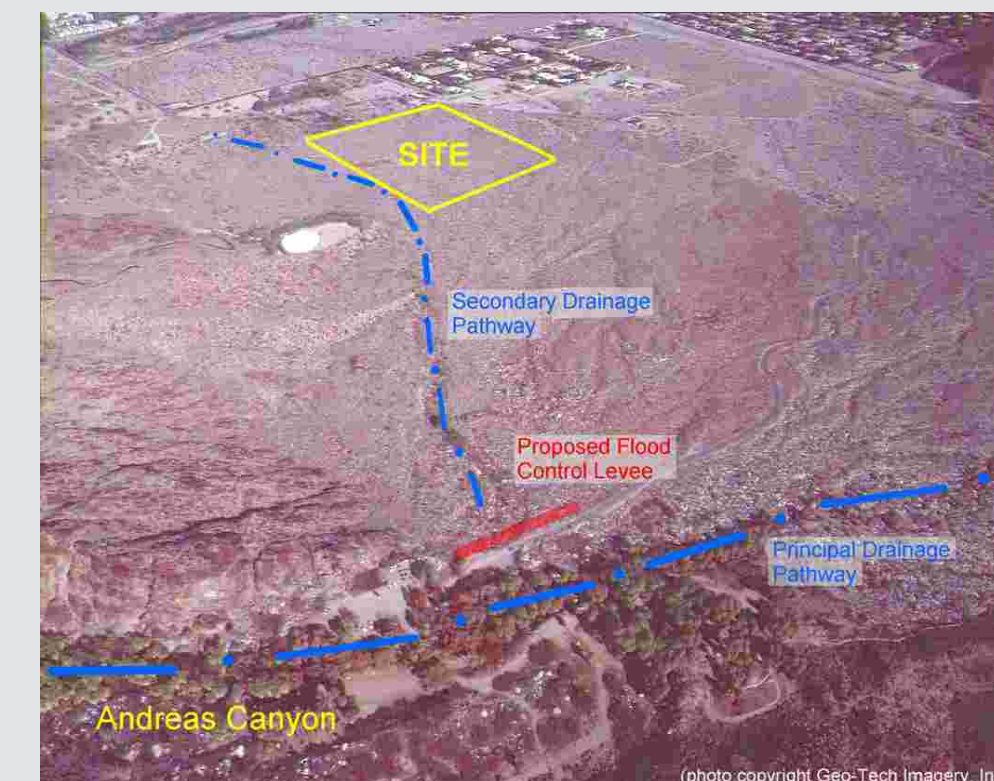
**Exhibit 6** Oblique aerial photo of Andreas Canyon fan showing surface drainage features

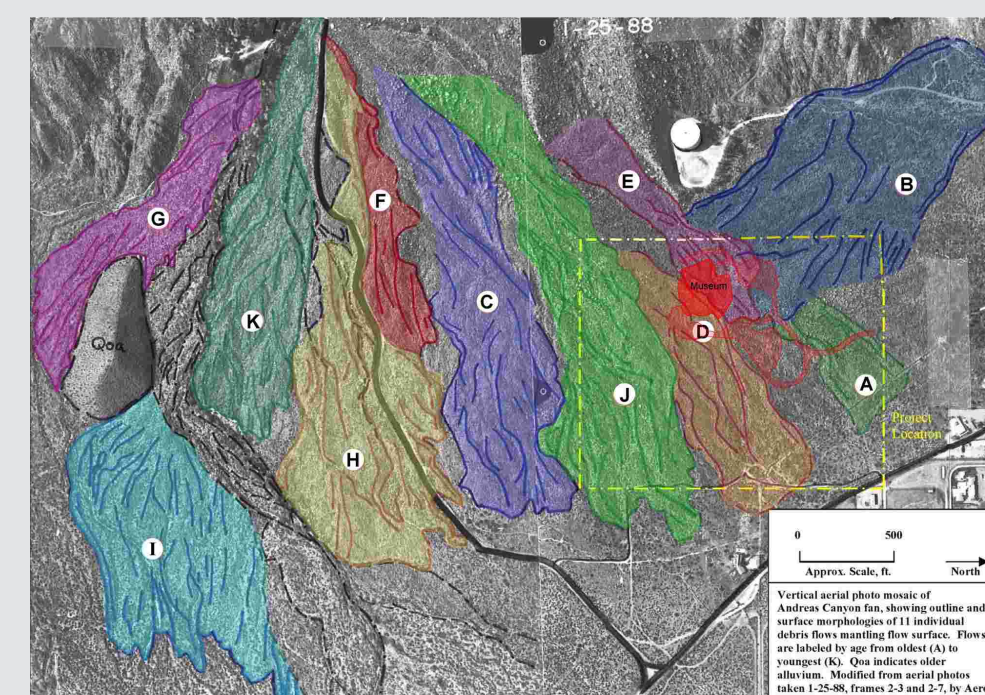
Aerial photo analysis of the Andreas Canyon fan suggests that at least 11 significant debris flow events are preserved on the fan surface. In the field, individual flows were distinguished using several characteristics, including: 1) degree of desert varnish formation; 2) the amount of in-place weathering of boulders; 3) the degree of preservation of the original depositional morphology; and 4) the degree of desert pavement development. Not including the embedded boulders, the flows are typically about 5 to 8 feet thick near the fan apex, and thin to about 1.5 to 4 feet at the toe. They measure about 300 to 800 feet wide and typically measure 3 to 5 times longer than they are wide. The volume of a mid-sized deposit on the fan is about 3.75 million cubic feet.

**Exhibit 7** Map of debris flow lobes on the Andreas Canyon fan

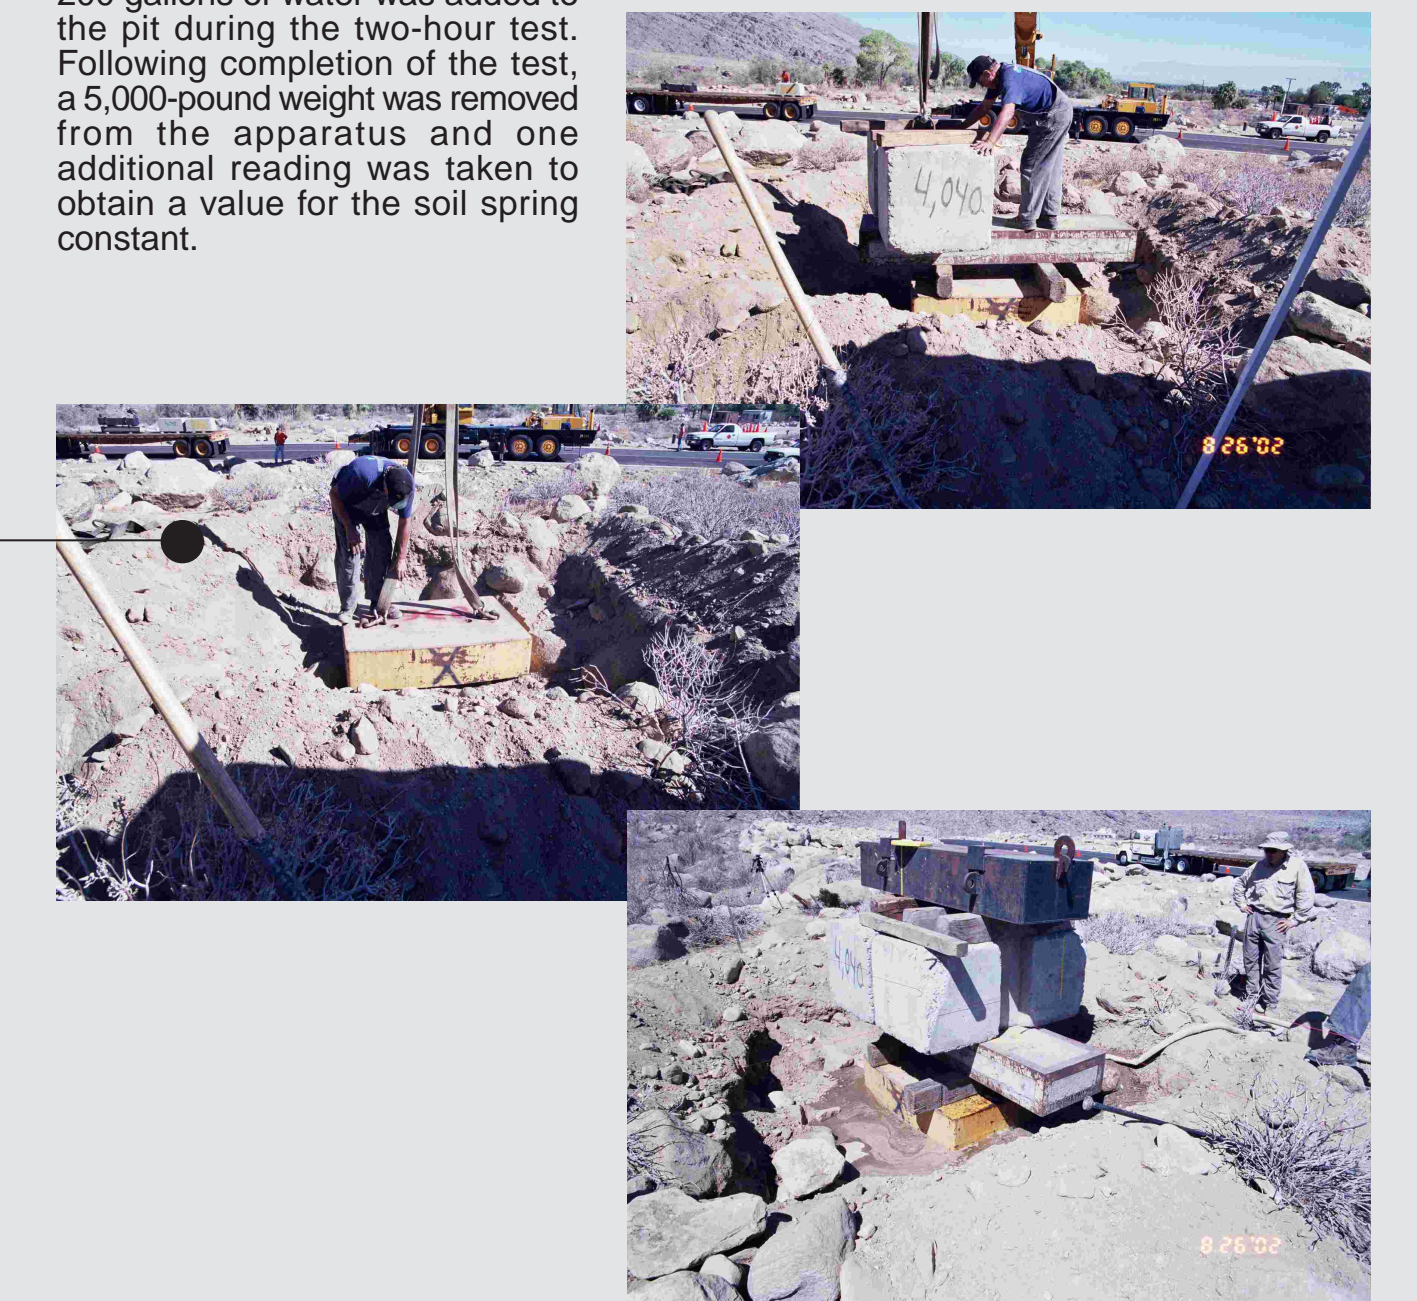
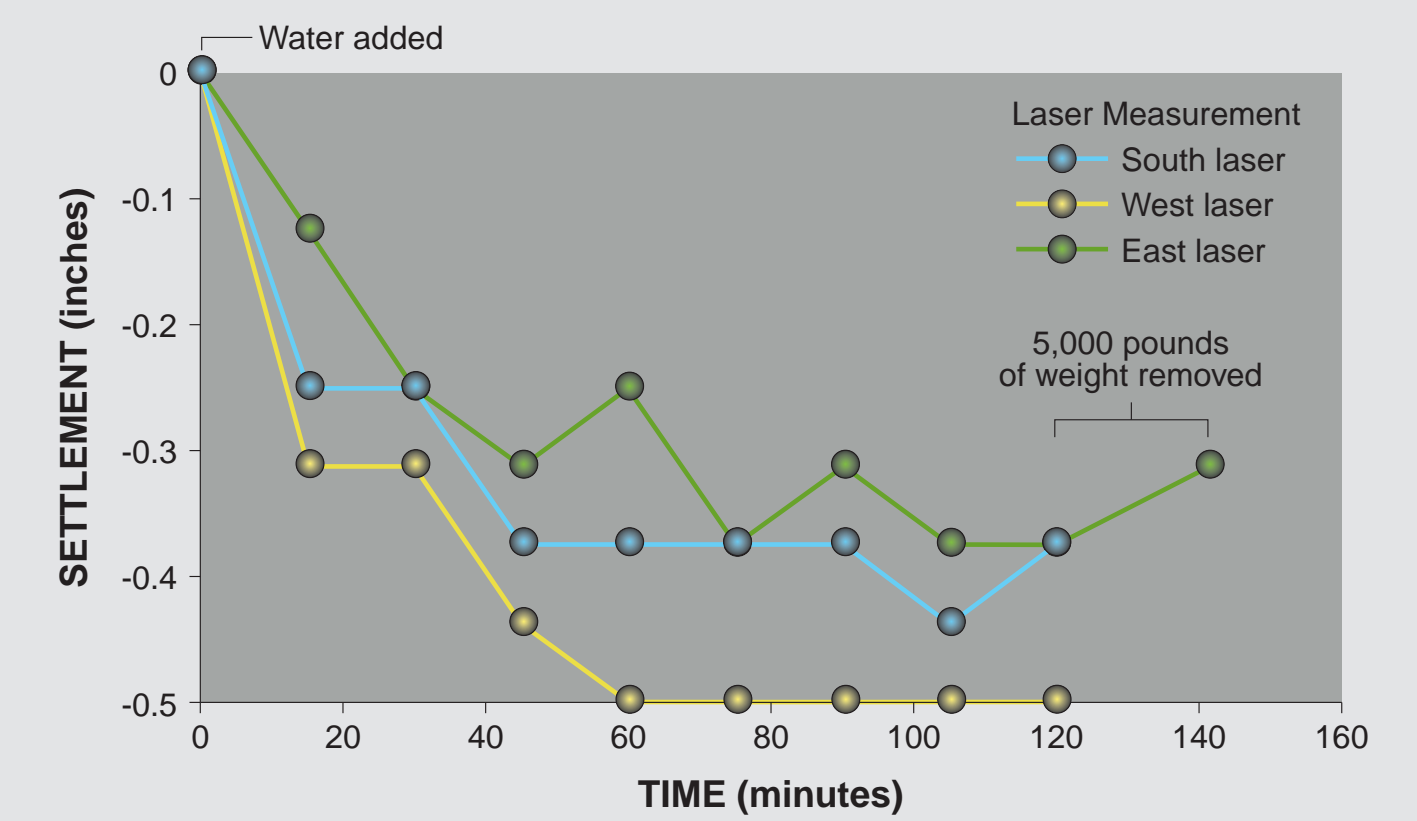
Exponent personnel performed a field hydroconsolidation test at the northern edge of the subject site. The pit was excavated over a 10-foot square area to a depth of approximately 1.5 feet, exposing debris flow deposits across the floor of the pit. A crane was used to set a series of weights into the test pit to simulate a footing load. A test weight of 24,980 pounds was applied over a 17.1 square foot area, resulting in a load of 1,461 lb/ft<sup>2</sup>. Water was added to the test pit and the settlement recorded over a two-hour period using three lasers directed at the apparatus from different sides. The water level was maintained at about 1 foot deep in the test pit by intermittent addition of water from a nearby fire hydrant.

The test apparatus recorded a total of \_ to \_ inch of settlement during the two-hour test. Most of the settlement occurred within the first 45 minutes. A total of approximately 200 gallons of water was added to the pit during the two-hour test. Following completion of the test, a 5,000-pound weight was removed from the apparatus and one additional reading was taken to obtain a value for the soil spring constant.

**Exhibit 9** Hydroconsolidation test results Agua Caliente Cultural Museum
